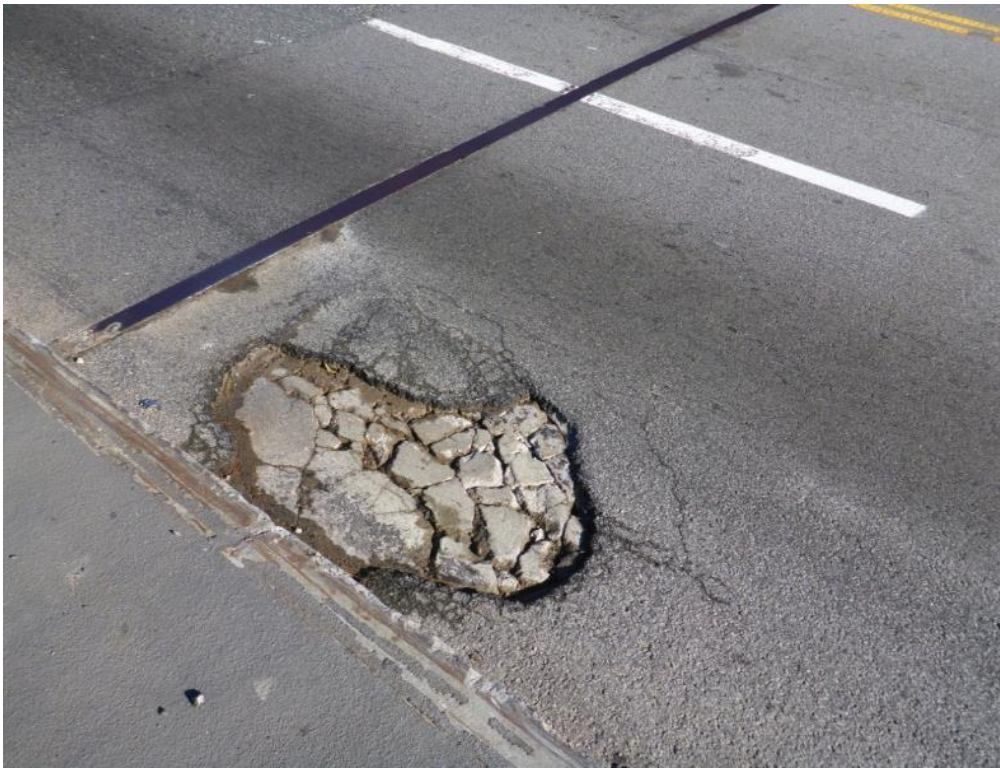
Photo 1 – Bourne Bridge, deteriorated deck of north abutment.

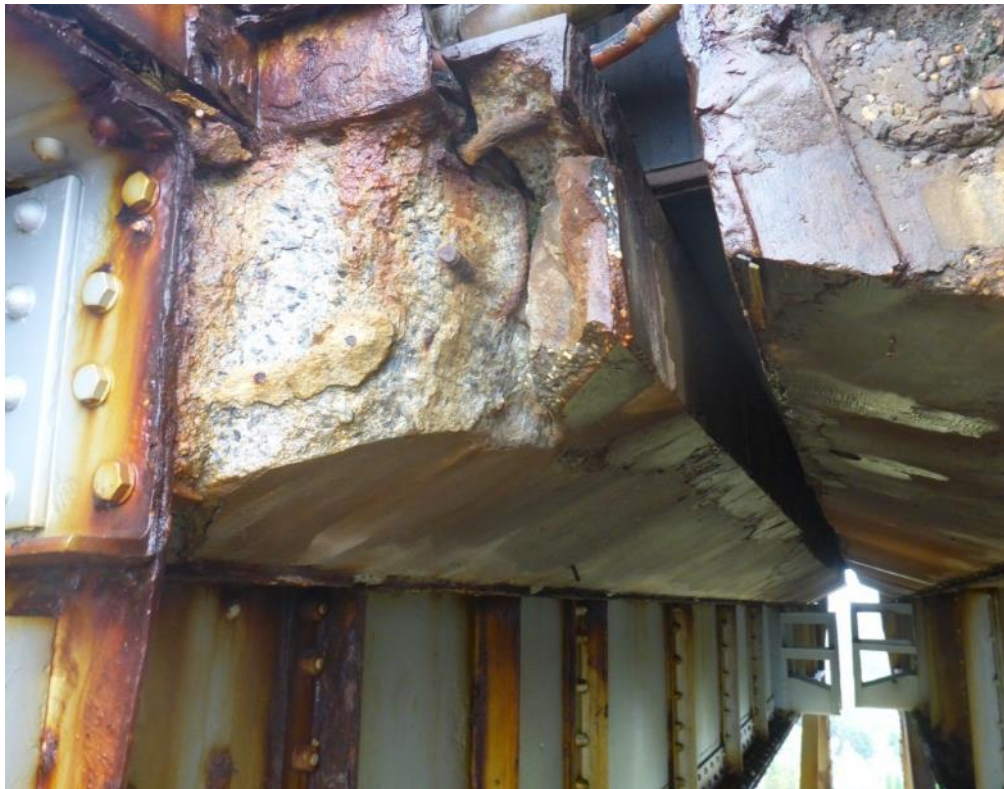
Photo 2 – Bourne Bridge, underside of Pier 3 deck joint.

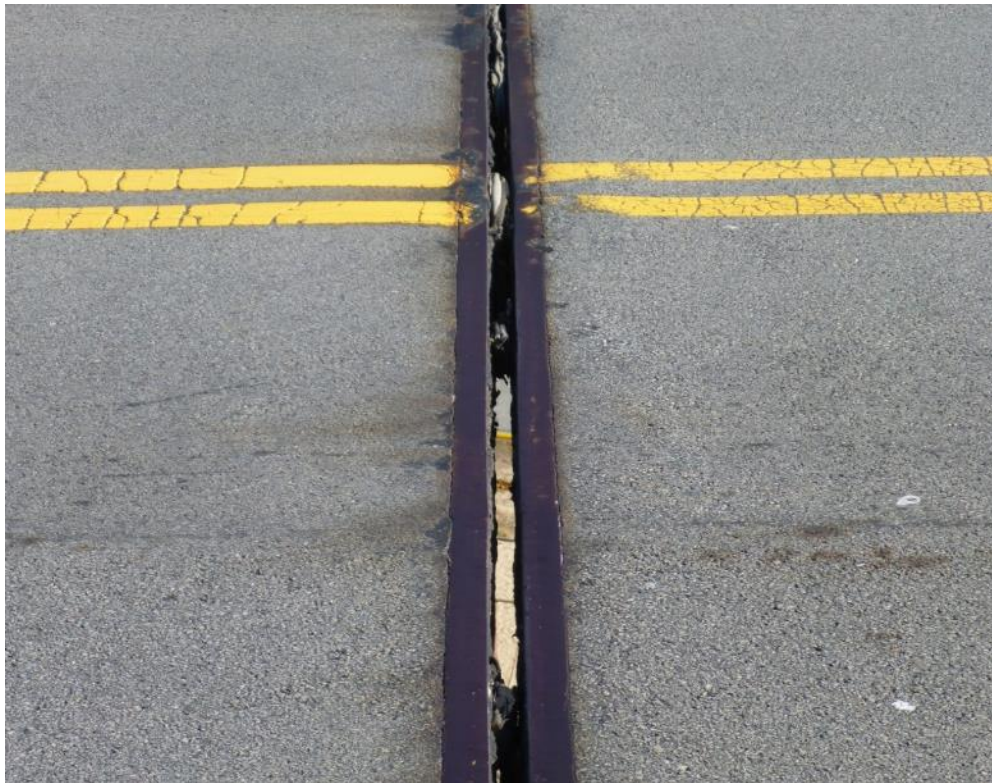
Photo 3 – Bourne Bridge, dislodged and missing compression seal @ Pier 6 deck joint.

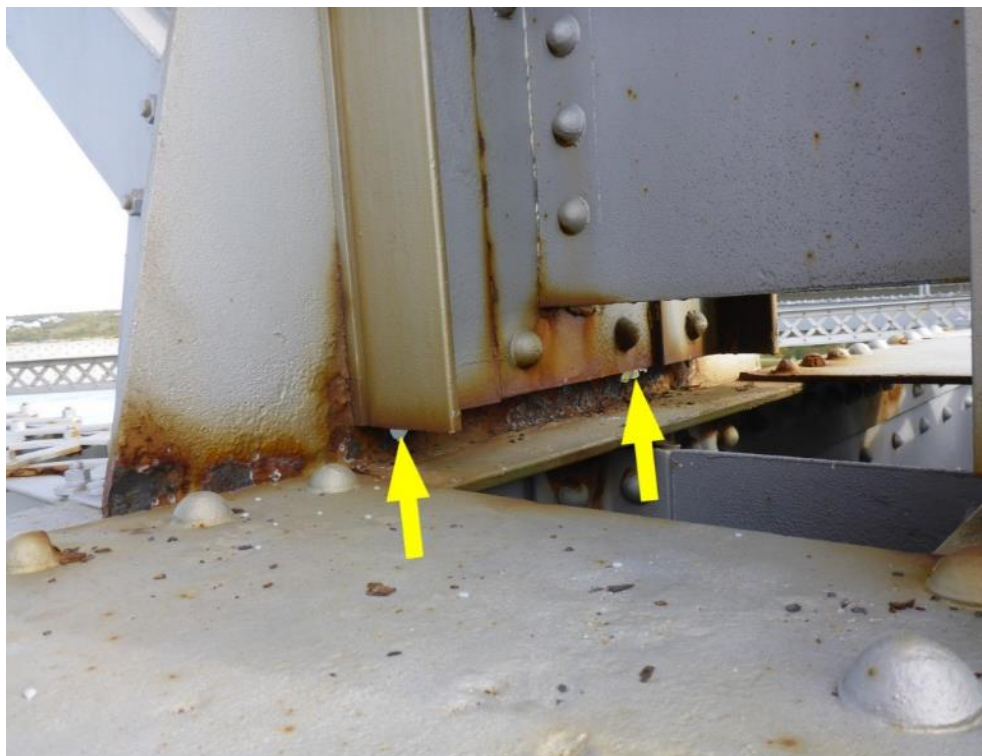
Photo 4 – Bourne Bridge, Span 2, west truss, east gusset plate at L7' with holes along the top of the lower chord member.

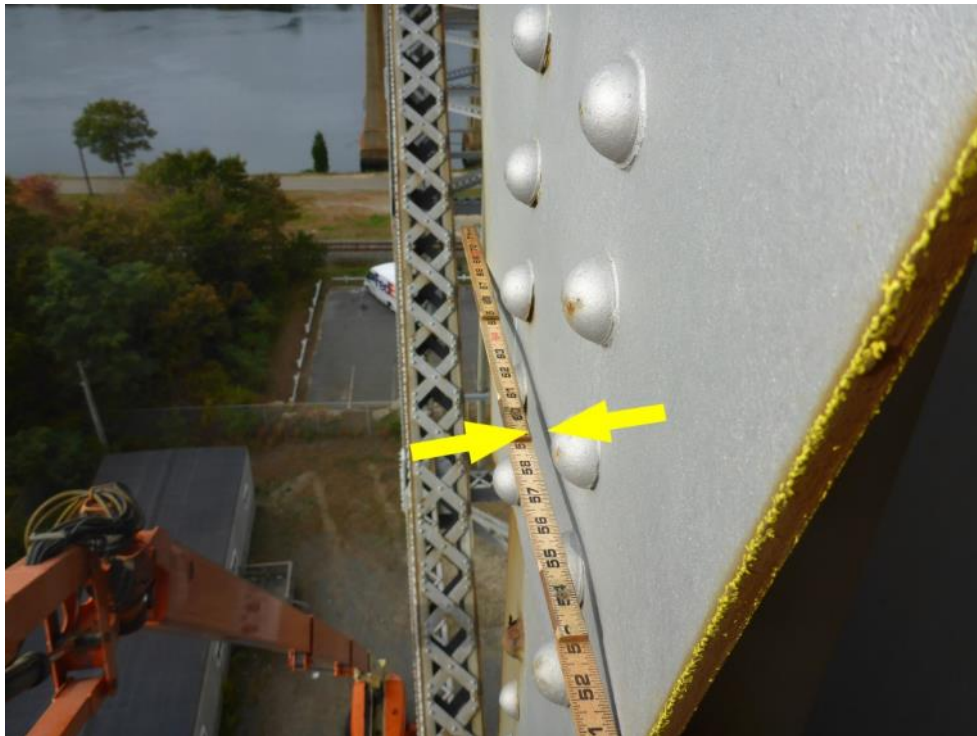
Photo 5 – Bourne Bridge, Span 3, west truss, west gusset plate at U0 with thick pack rust along both edges deforming the gusset plate.

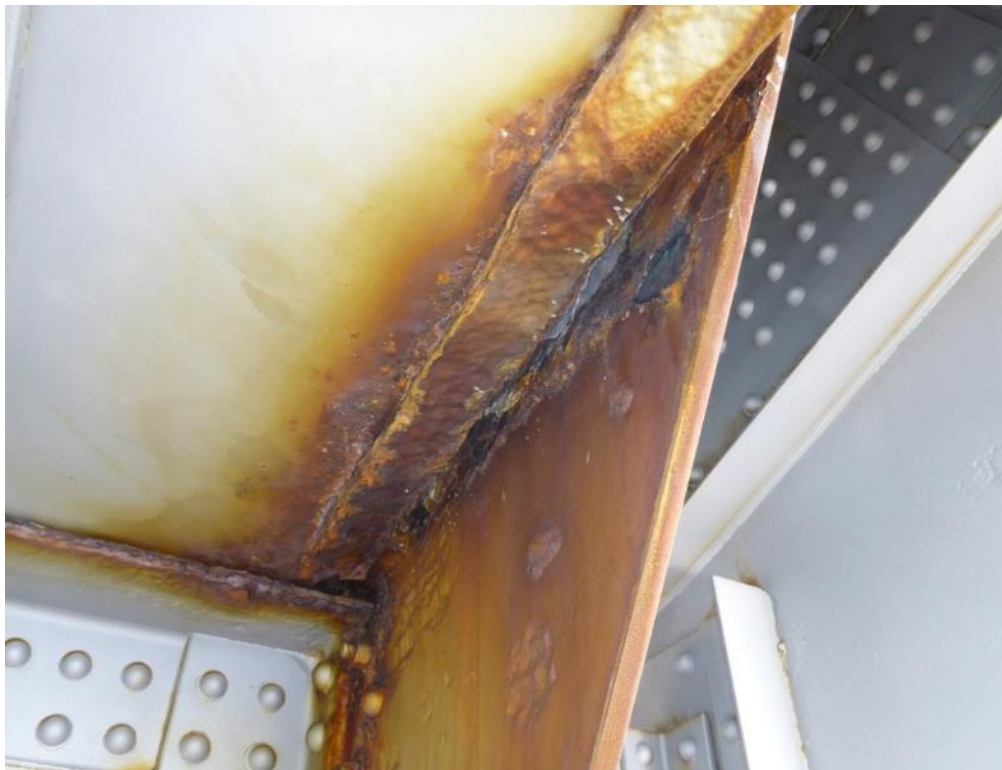
Photo 6 – Bourne Bridge, Span 2, east truss, west gusset plate at U6': section loss with active corrosion along the interface with the sidewalk curb channel.

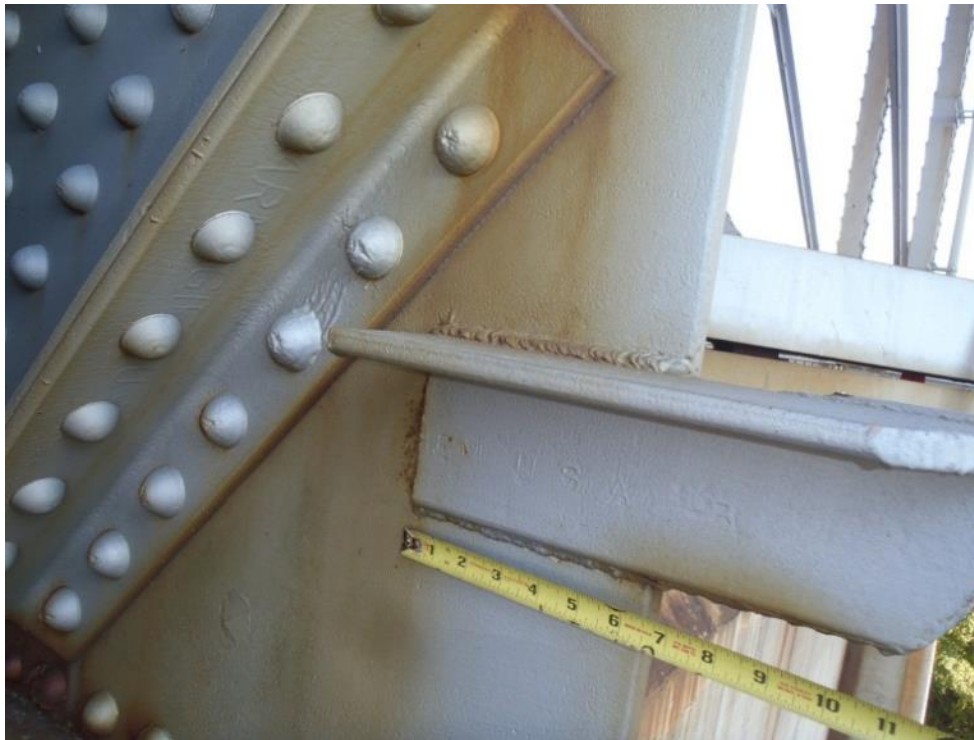
Photo 7 – Bourne Bridge, Span 4, west truss joint L8: Angle welded to the interior face of the east gusset plate (considered a FSD).

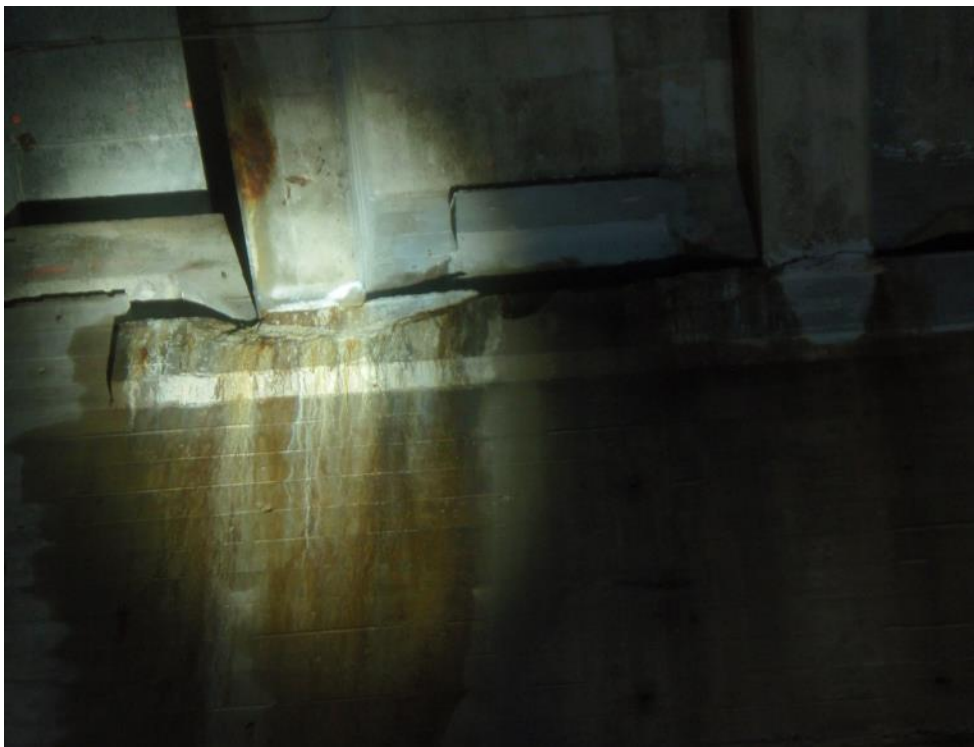
Photo 8 – Bourne Bridge, Beam BM1, chamber 2 of the south abutment: The bearing area is undermined resulting in a 33% reduction in bearing area.

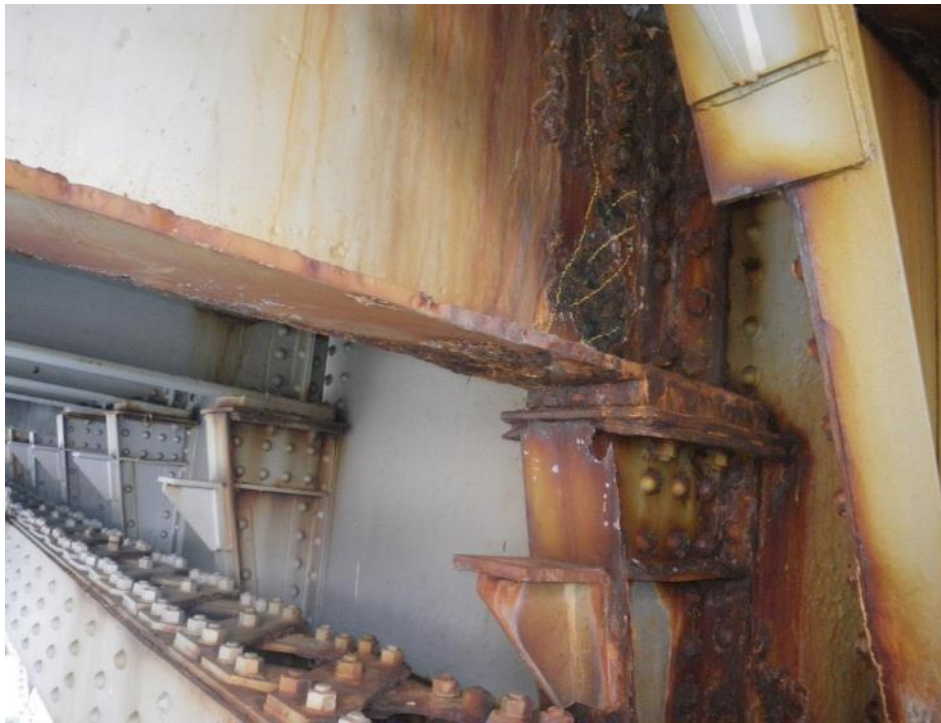
Photo 9 – Bourne Bridge, Span 1, north side of floorbeam FB10: Active corrosion with 1/16" loss by full height of the web.

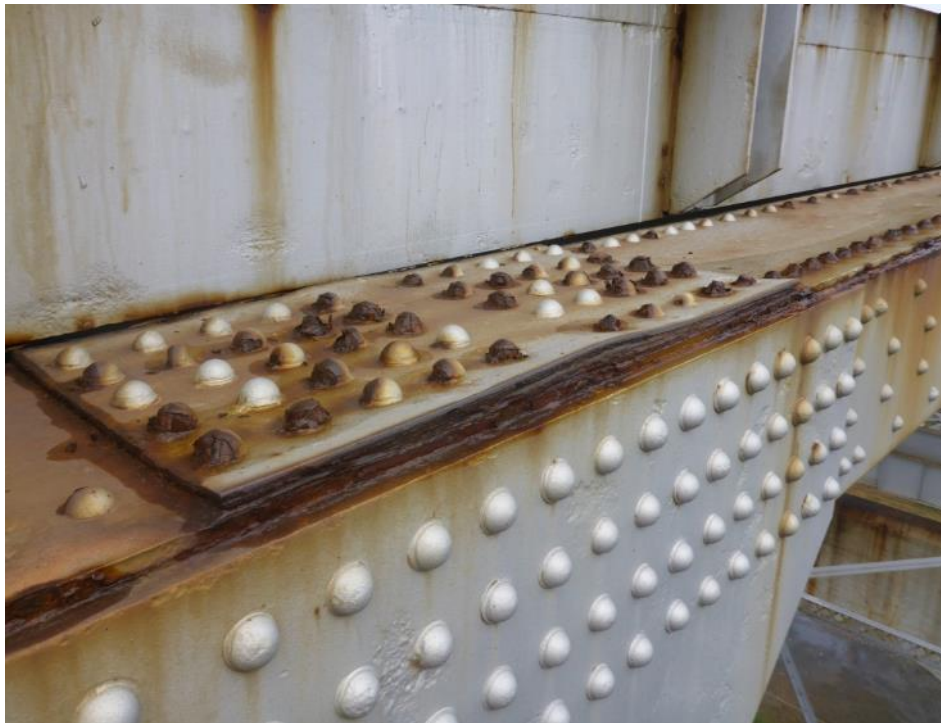
Photo 10 – Bourne Bridge, Span 5, east truss upper chord member U5U6 has up to 1" thick pack rust at the top splice plate with active corrosion on the rivet heads.

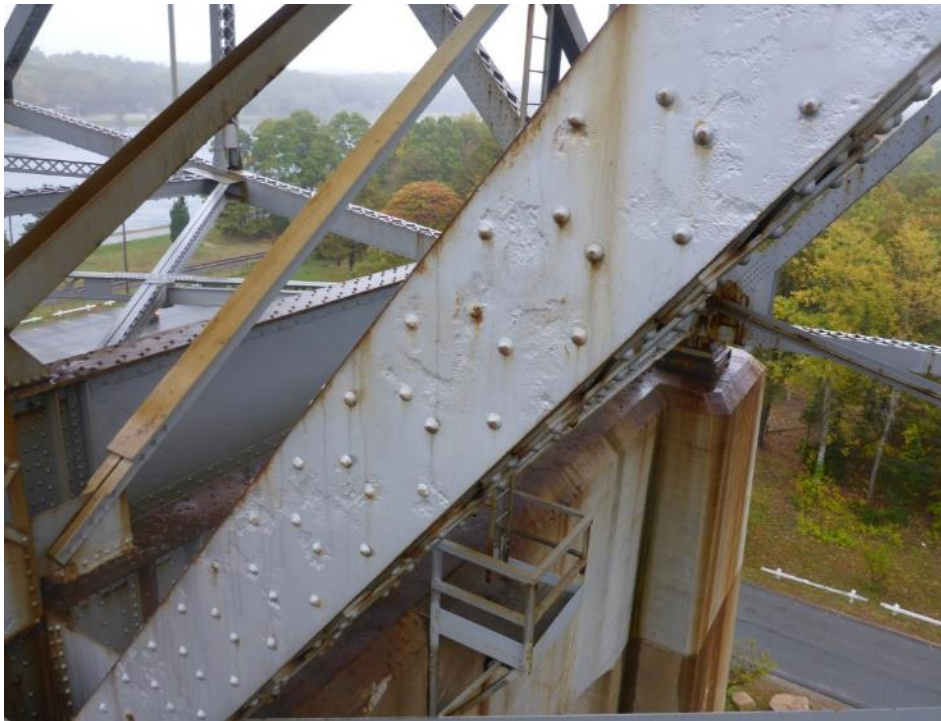
Photo 11 – Bourne Bridge, Span 5, west truss diagonal L8U7: Widespread 1/16" deep pitting.

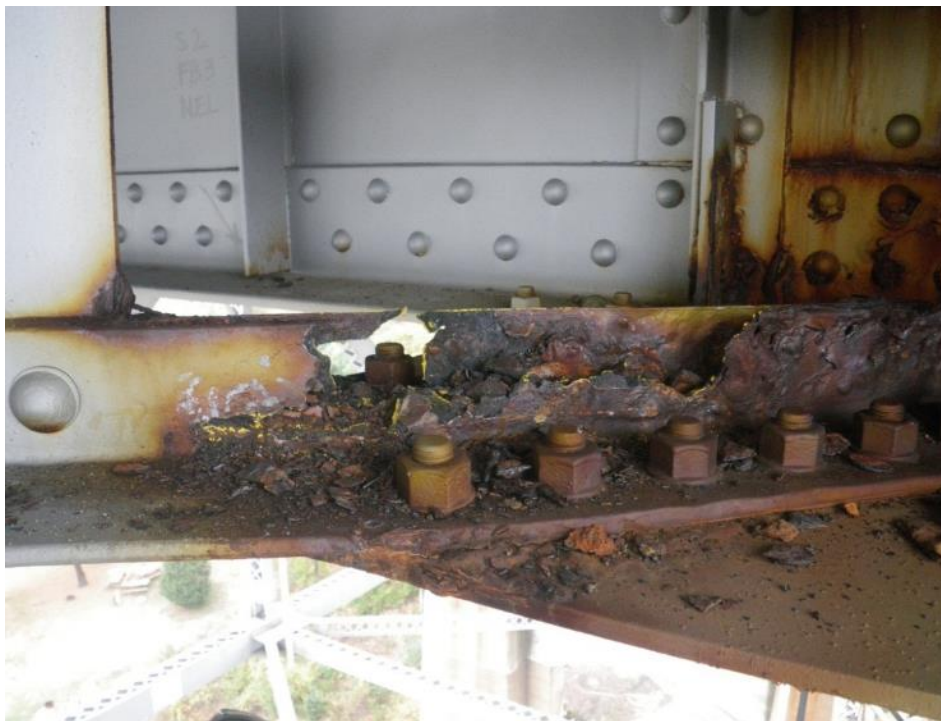
Photo 12 – Bourne Bridge, Span 2, upper lateral bracing at the connection to the east truss at U3': 100% loss by full height of both vertical legs of the bottom flange angles.

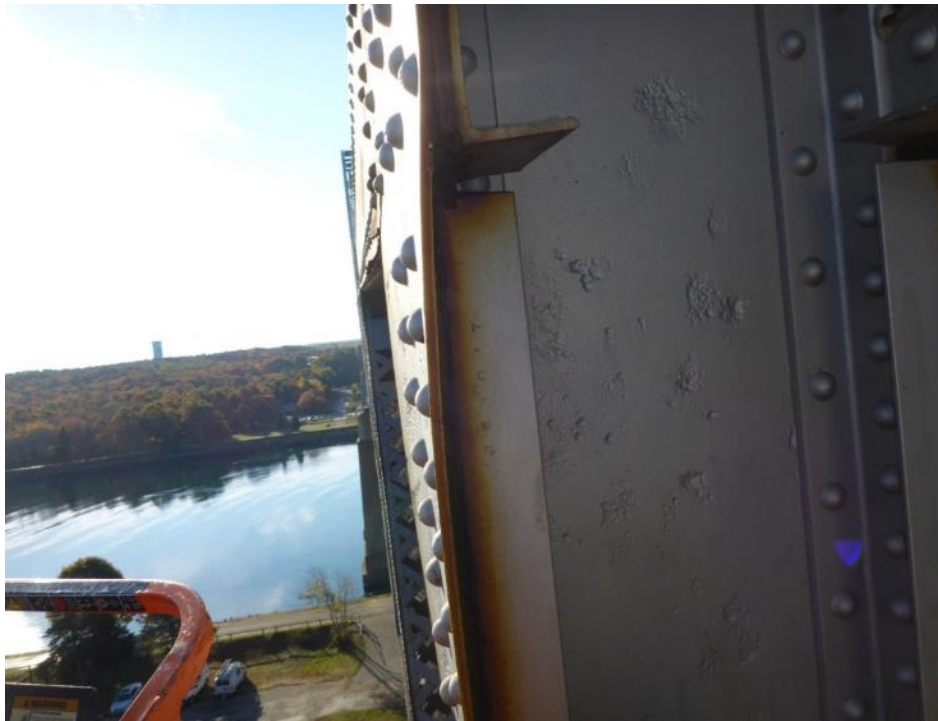
Photo 13 – Bourne Bridge, Span 2, east truss, east gusset plate at U0': 1/2" thick pack rust along both edges of the truss vertical member with deforming of the gusset plate.

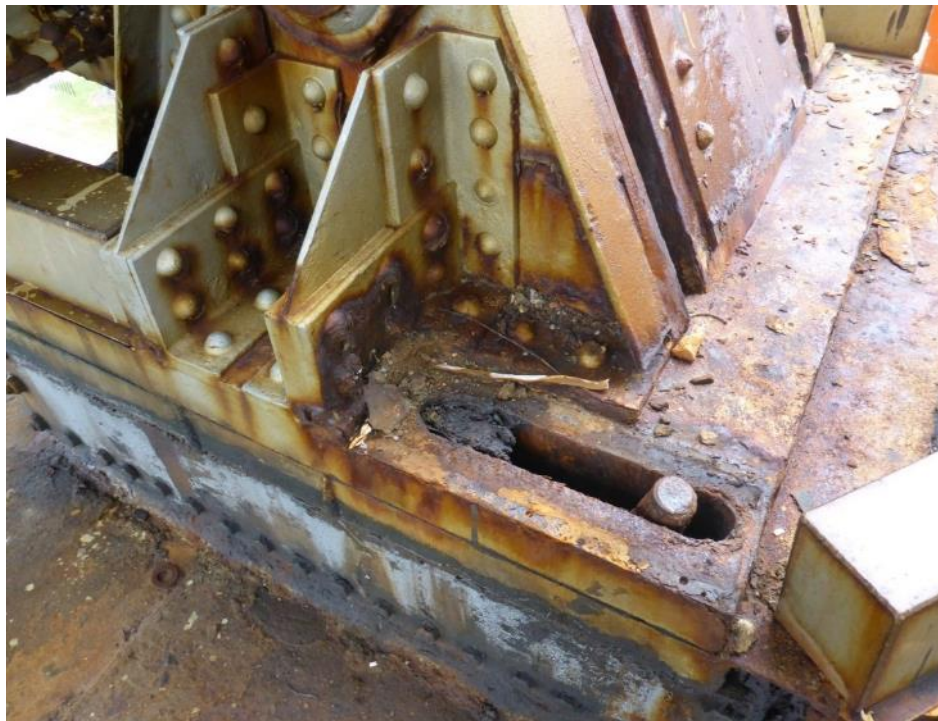
Photo 14 – Bourne Bridge, Span 3, east bearing at pier 3 has a detached covering and a broken anchor bolt.

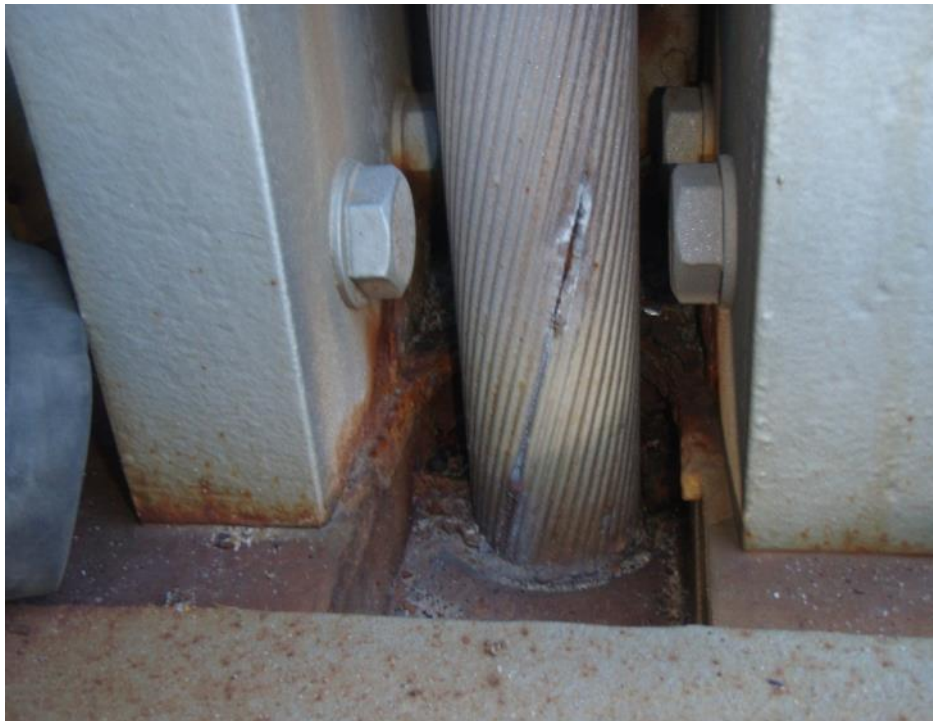
Photo 15 – Bourne Bridge, south suspender at east truss joint 14': A 1/16" wide gap by 6" long between two wires, indicative of stage IV corrosion.

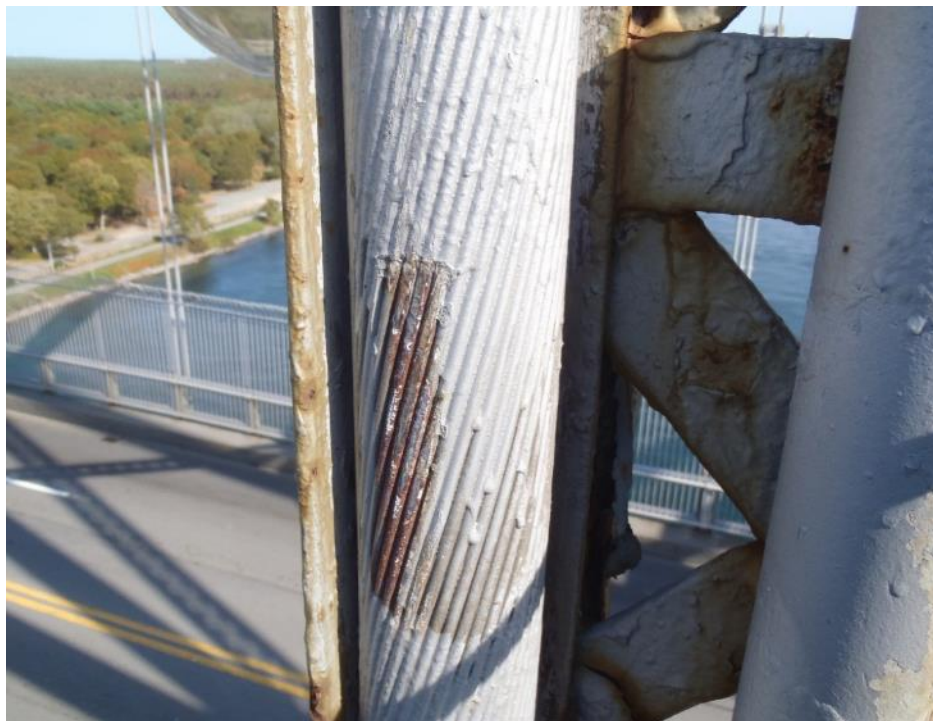
Photo 16 – Bourne Bridge, North suspender at west truss joint 13: Area of stage IV corrosion.

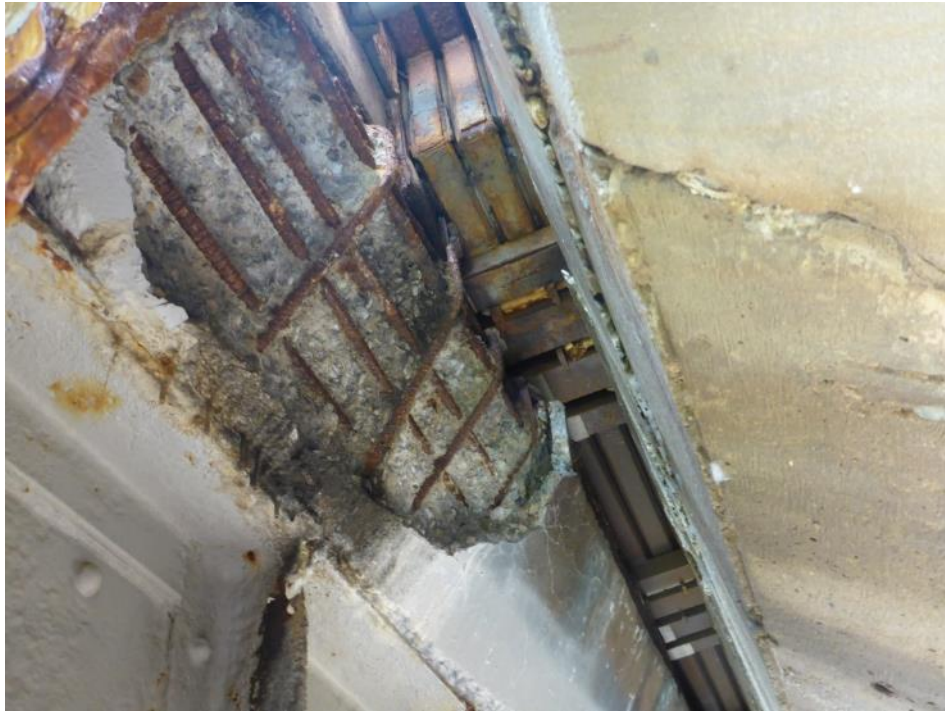
Photo 17 – Sagamore Bridge, deteriorated joint header at south abutment.
Repaired in 2018.

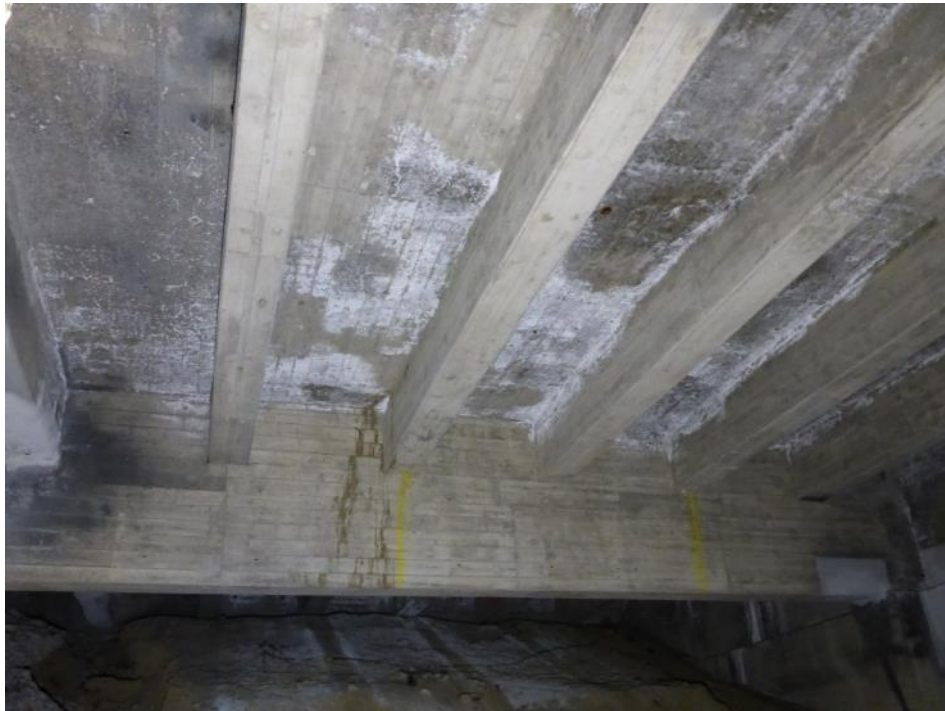
Photo 18 – Sagamore Bridge, efflorescence in the underside of the deck in chamber 1 of the south abutment.

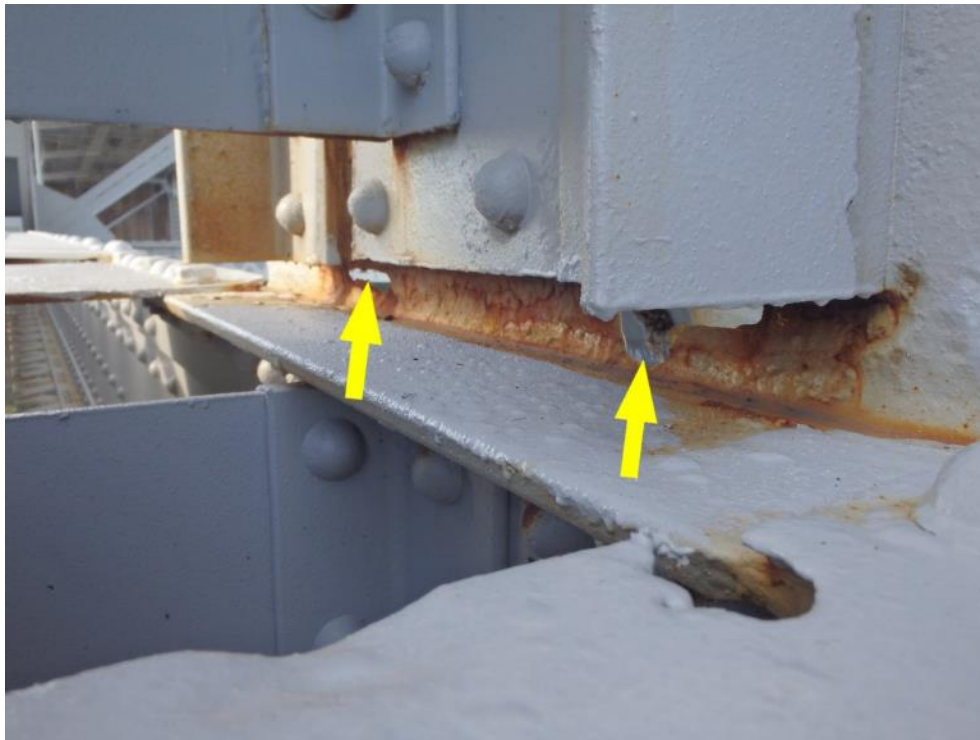
Photo 19 – Sagamore Bridge, advanced deterioration to the west gusset plate at truss joint L7 of the east truss in span 3.

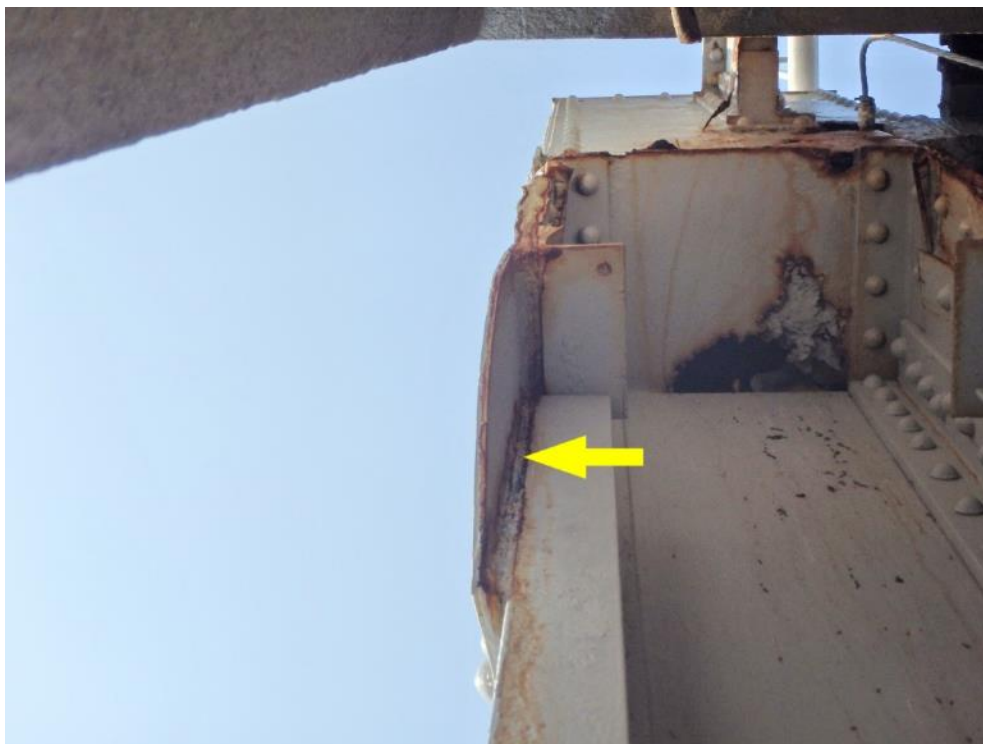
Photo 20 – Sagamore Bridge, pack rust along the north edge of truss vertical member deforming the gusset plate at truss joint U0' of the east truss.

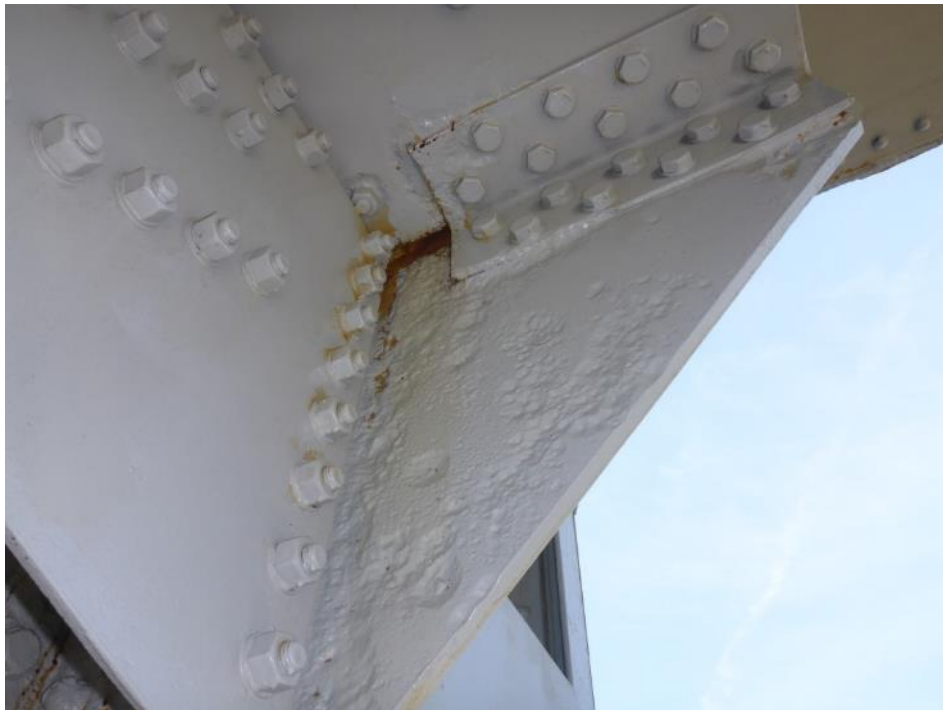
Photo 21 – Sagamore Bridge, heavy pitting on the interior face of the east gusset plate at truss joint U0 of the west truss.

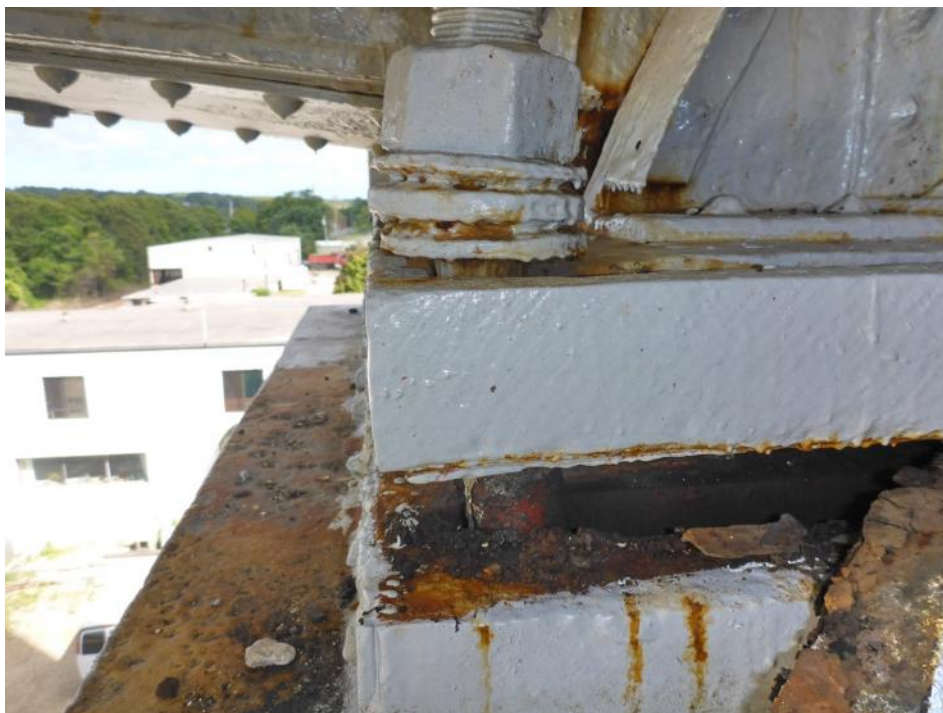
Photo 22 – Sagamore Bridge, bent anchor bolt at the south abutment out of plumb 1/4".

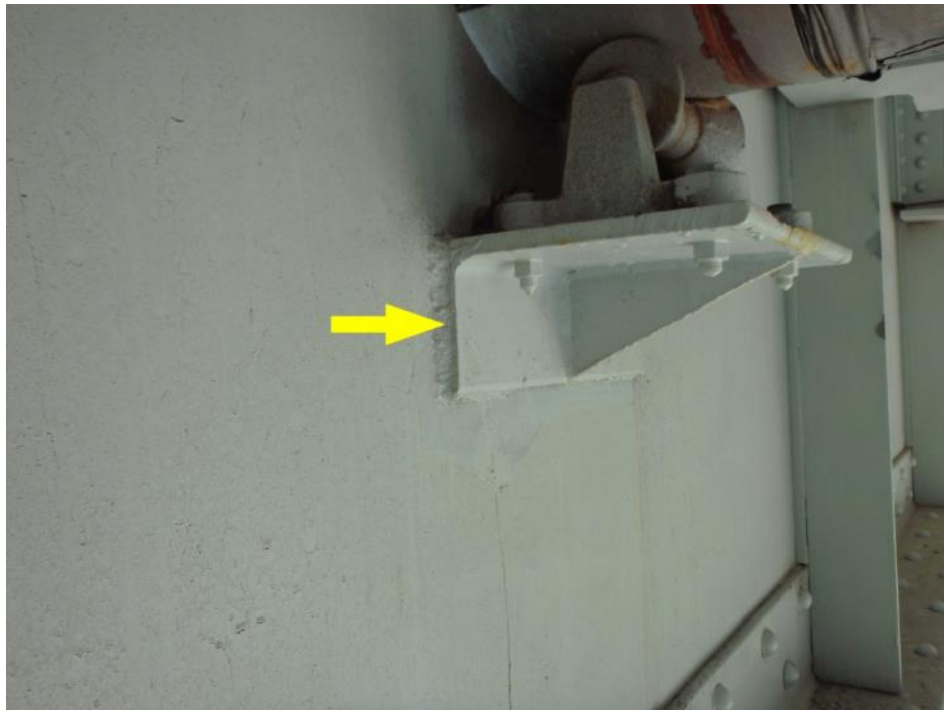
Photo 23 – Sagamore Bridge, fatigue sensitive detail utility bracket welded to the north face of the web of floorbeam FB5'.

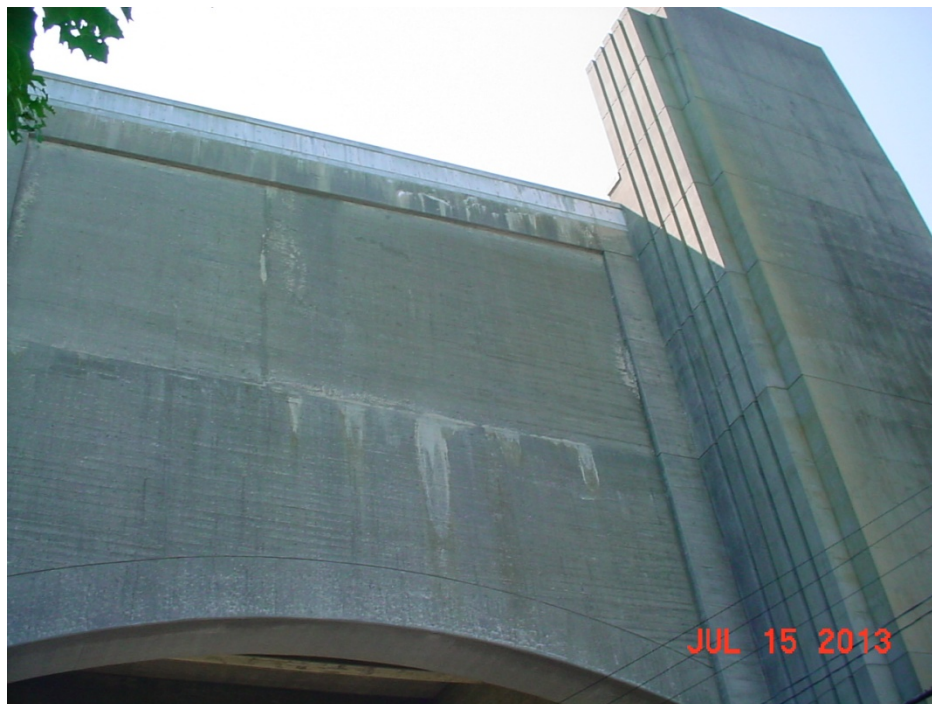
Photo 24 – Sagamore Bridge, South Abutment on East Face exhibits an area of delaminating concrete 4'x1' which may pose a future falling hazard.

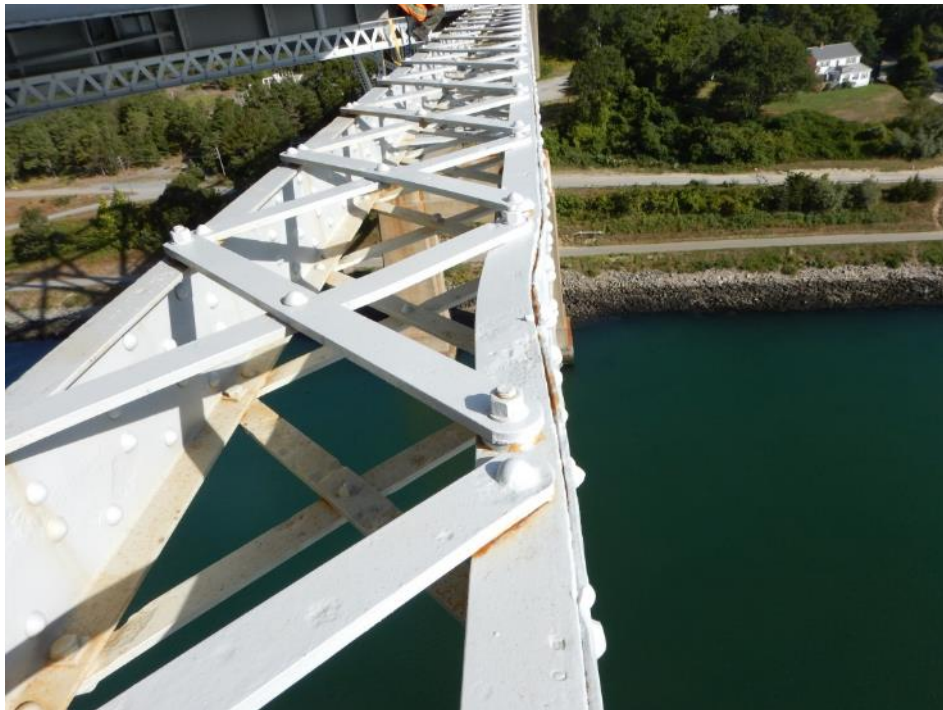
Photo 25 – Sagamore Bridge, impact damage to the east wind chord.

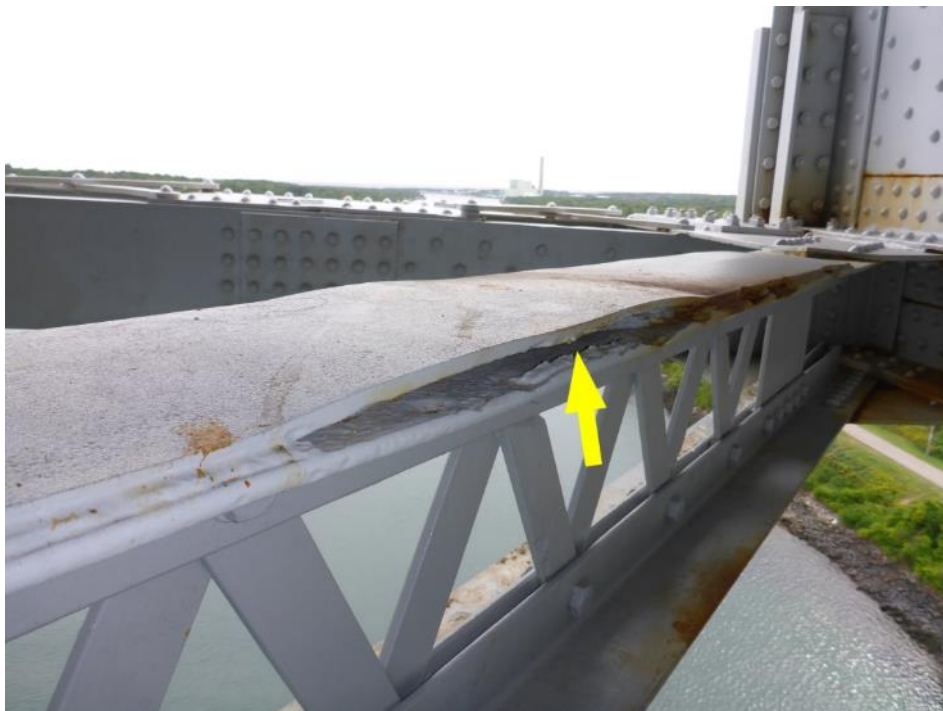
Photo 26 – Sagamore Bridge, fully cracked weld along the top flange cover plate repair.

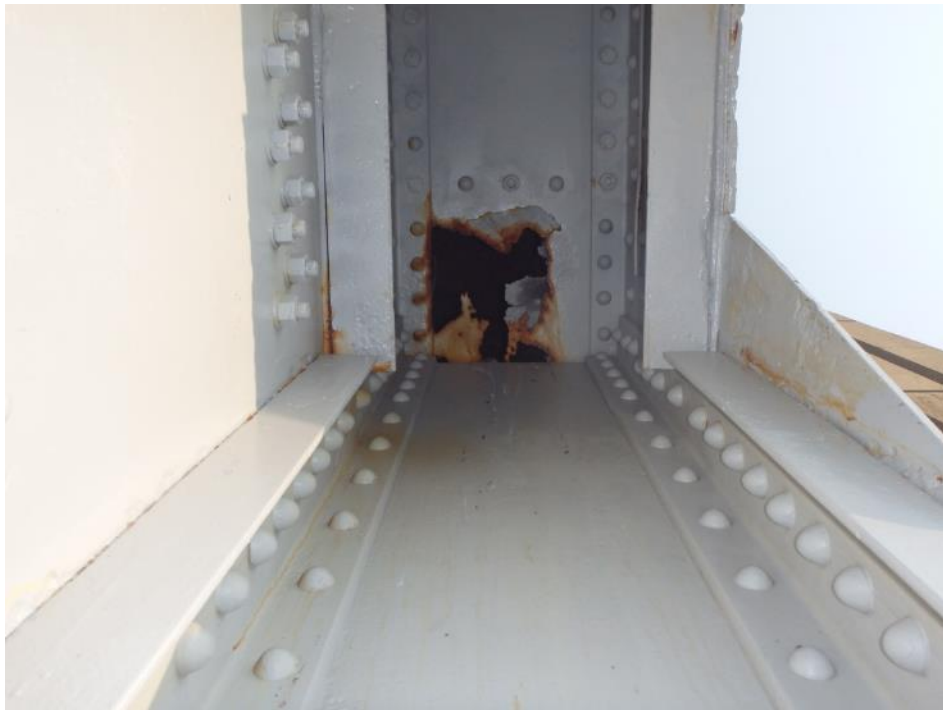
Photo 27 – Sagamore Bridge, corrosion hole in the internal longitudinal stiffener plate of east truss upper chord member U0'U1' in span 2.

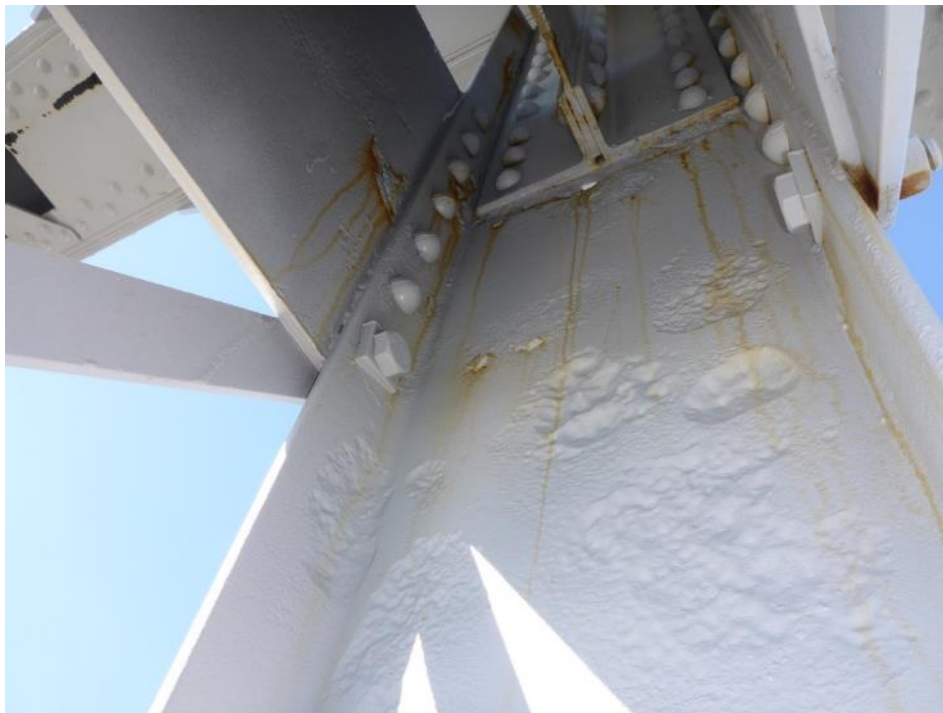
Photo 28 – Sagamore Bridge, area of pitting to the interior face of east truss vertical member in span 1.

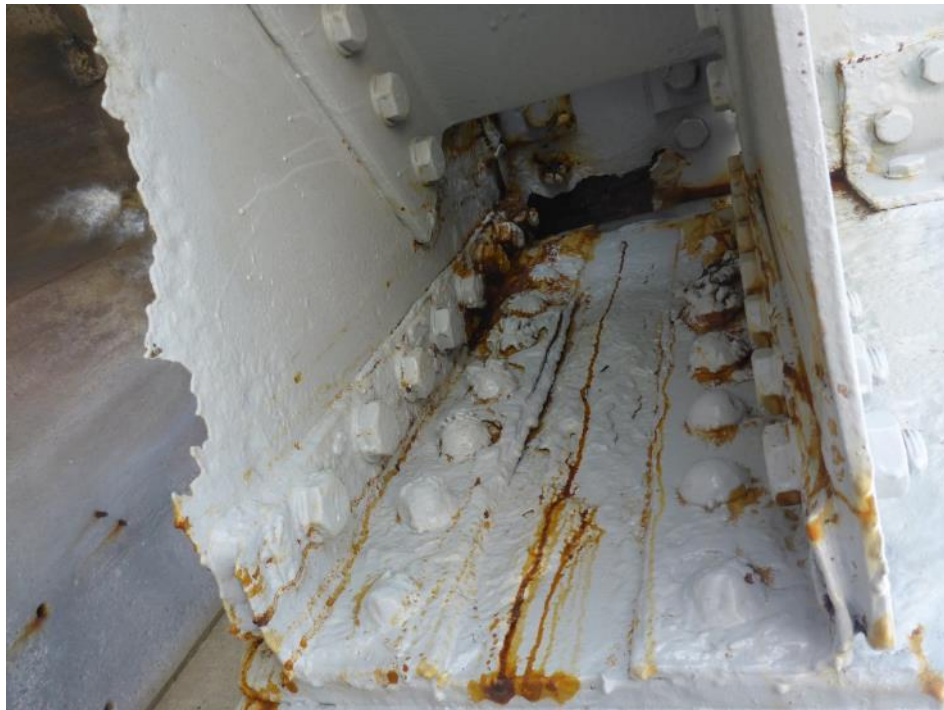
Photo 29 – Sagamore Bridge, interior view of the south connection plate of sway brace with advanced deterioration.

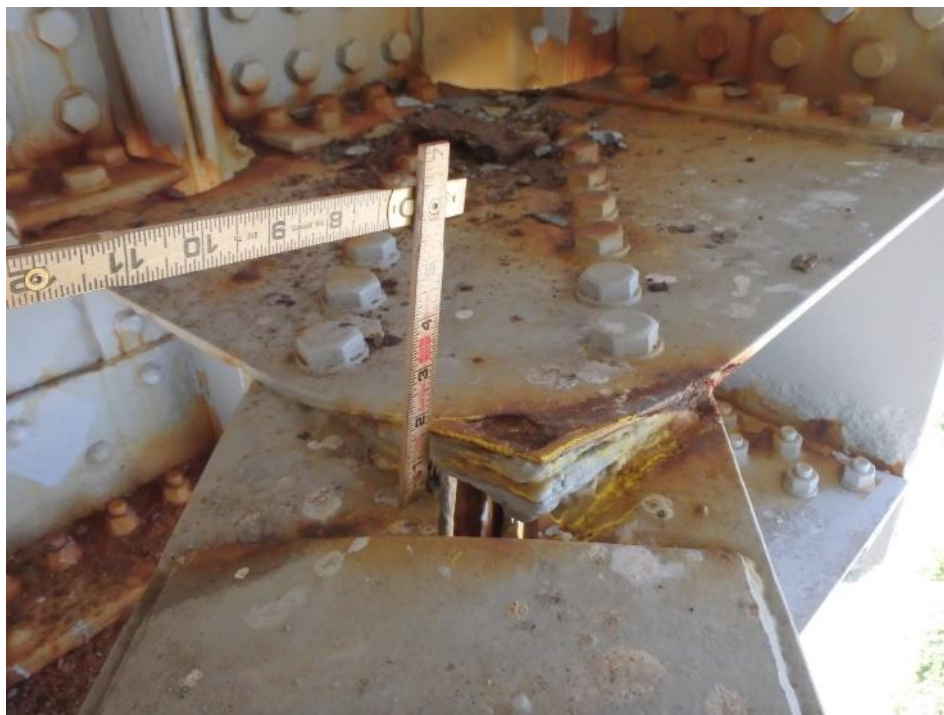
Photo 30 – Sagamore Bridge, pack rust between the upper connection plate and the upper lateral bracing between truss joints at U1 in span 3.

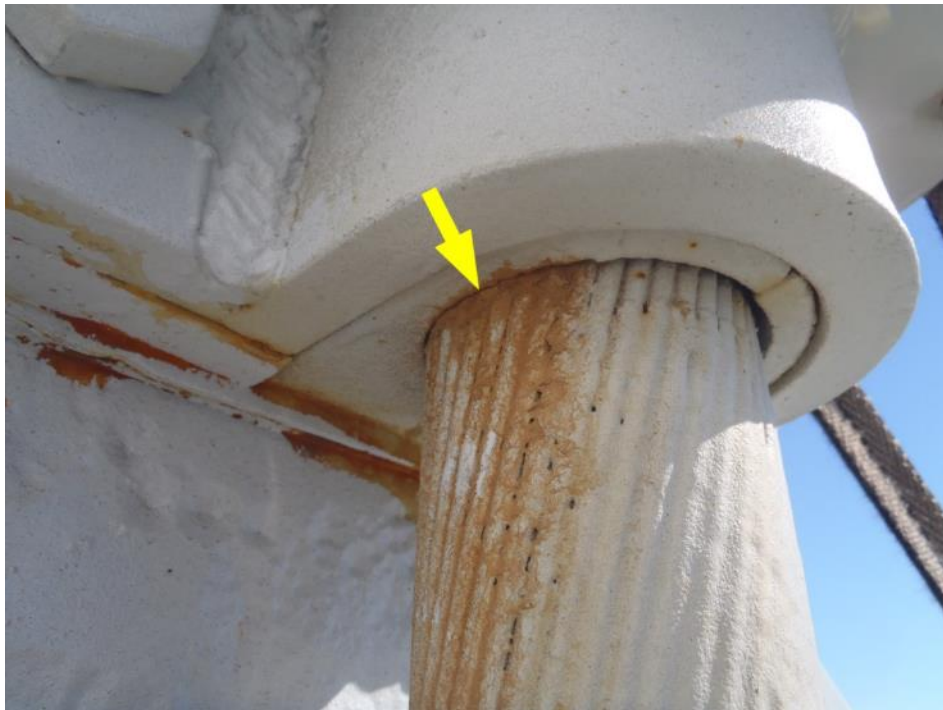
Photo 31 – Sagamore Bridge, misalignment with rubbing between the collar assembly and the south suspender cable at truss joint 15 of the east truss.

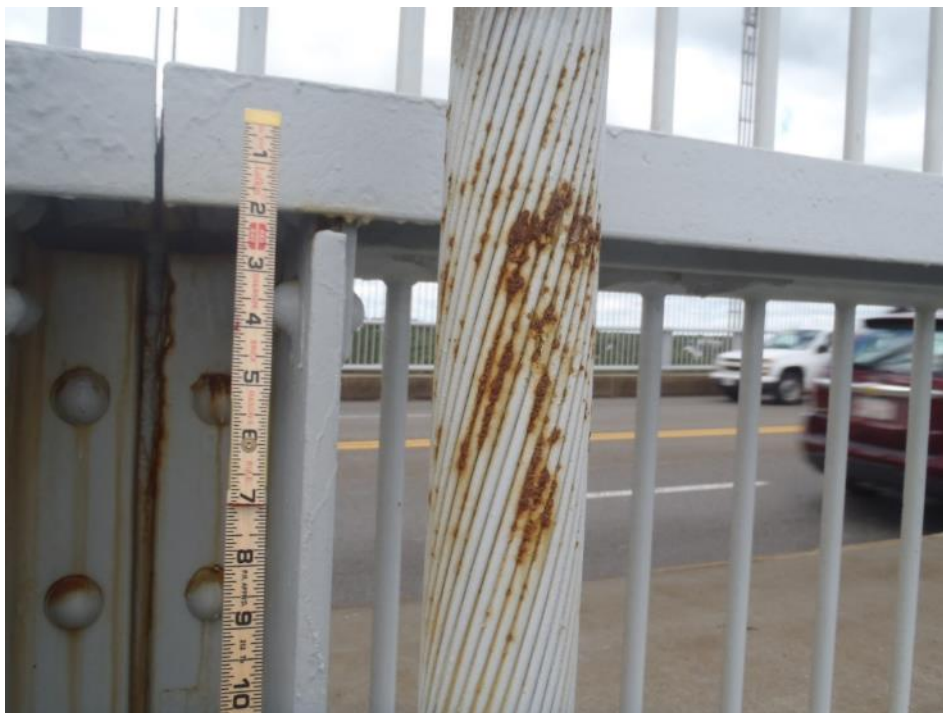
Photo 32 – Sagamore Bridge, area of stage III corrosion on the south suspender at east truss joint 12 between the top and bottom rails of the railing.
